Manhole Inspection Summary

Manhole # S19II_039MH

Insp Date: **6/20/07 12:09 PM**

Location Address: **2101 PULASKI ST**

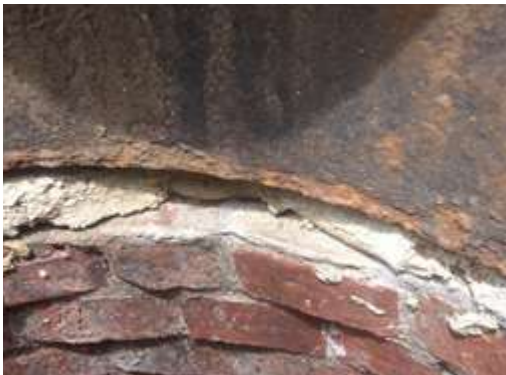
Defect 2

Condition: ☐ Sound ☐ Cracked ☐ Root Intrusion ☐ Loose Brick ☒ **Deteriorated**

DETERIORATION OF CHIMNEY

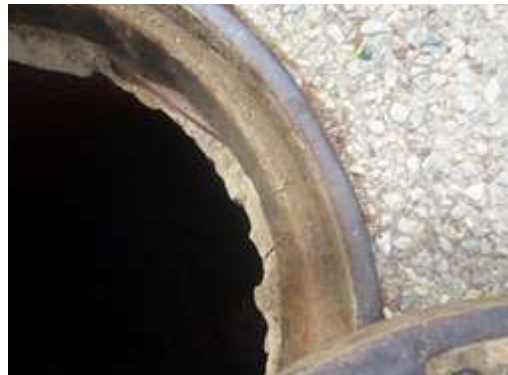
Defect 1

Offset: **1** (in.)

FRAME OFFSET

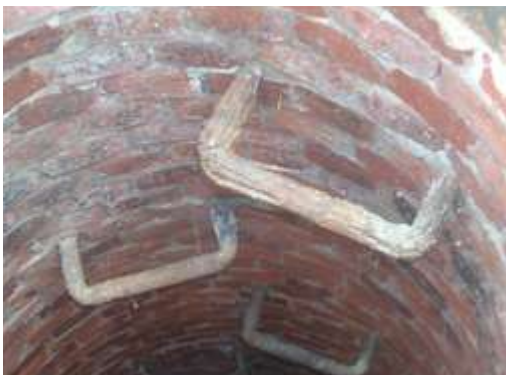
Defect 3

Count: **8** Missing: **0** ☒ **Corroded**

STEPS ARE CORRODED

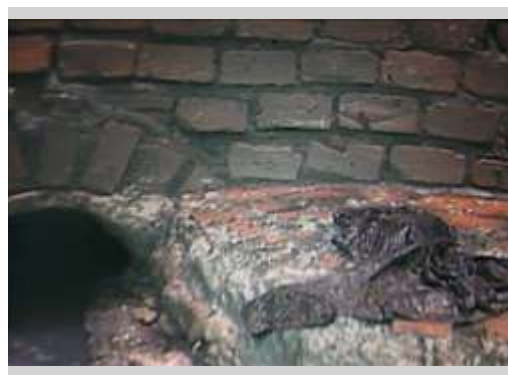
Defect 5

Condition: ☐ Sound ☐ Cracked ☐ Root Intrusion ☒ **Deteriorated** ☐ Leaks ☐ Debris

DETERIORATION OF THE BENCH

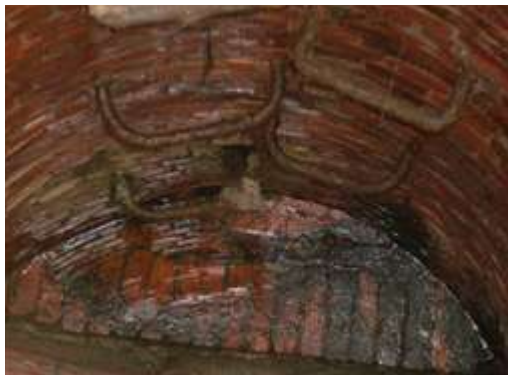
Defect 4

☒ **Evidence Of Surcharge** Depth: **4** (ft.) ☐ Active Surcharge Present

EVIDENCE OF SURCHARGE ON
STEPS

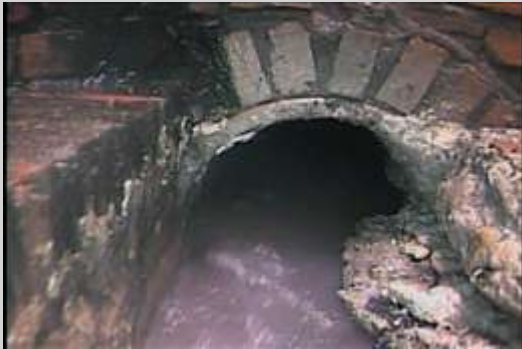
12 O'Clock Outflow

Pipe Height: **14.4** (in.) Rod and Bar (Angled)
Pipe Material: **Clay** ☐ Pipe Lined
Invert Depth: **13.94** (ft.) Flow Characteristics: **Fast**
Deposits: ☐ None ☐ Mud ☐ Sludge ☒ **Debris** ☐ Grease
Silt Depth: **3** (in.) Deposits Extent: **Light**
Infiltration: **None** Pipe Seal Cond: **Broken**
